Making EIFS Watertight

by **Harrison McCampbell, AIA**

Properly installed backer rod and caulk are the keys to a long-lasting, trouble-free application

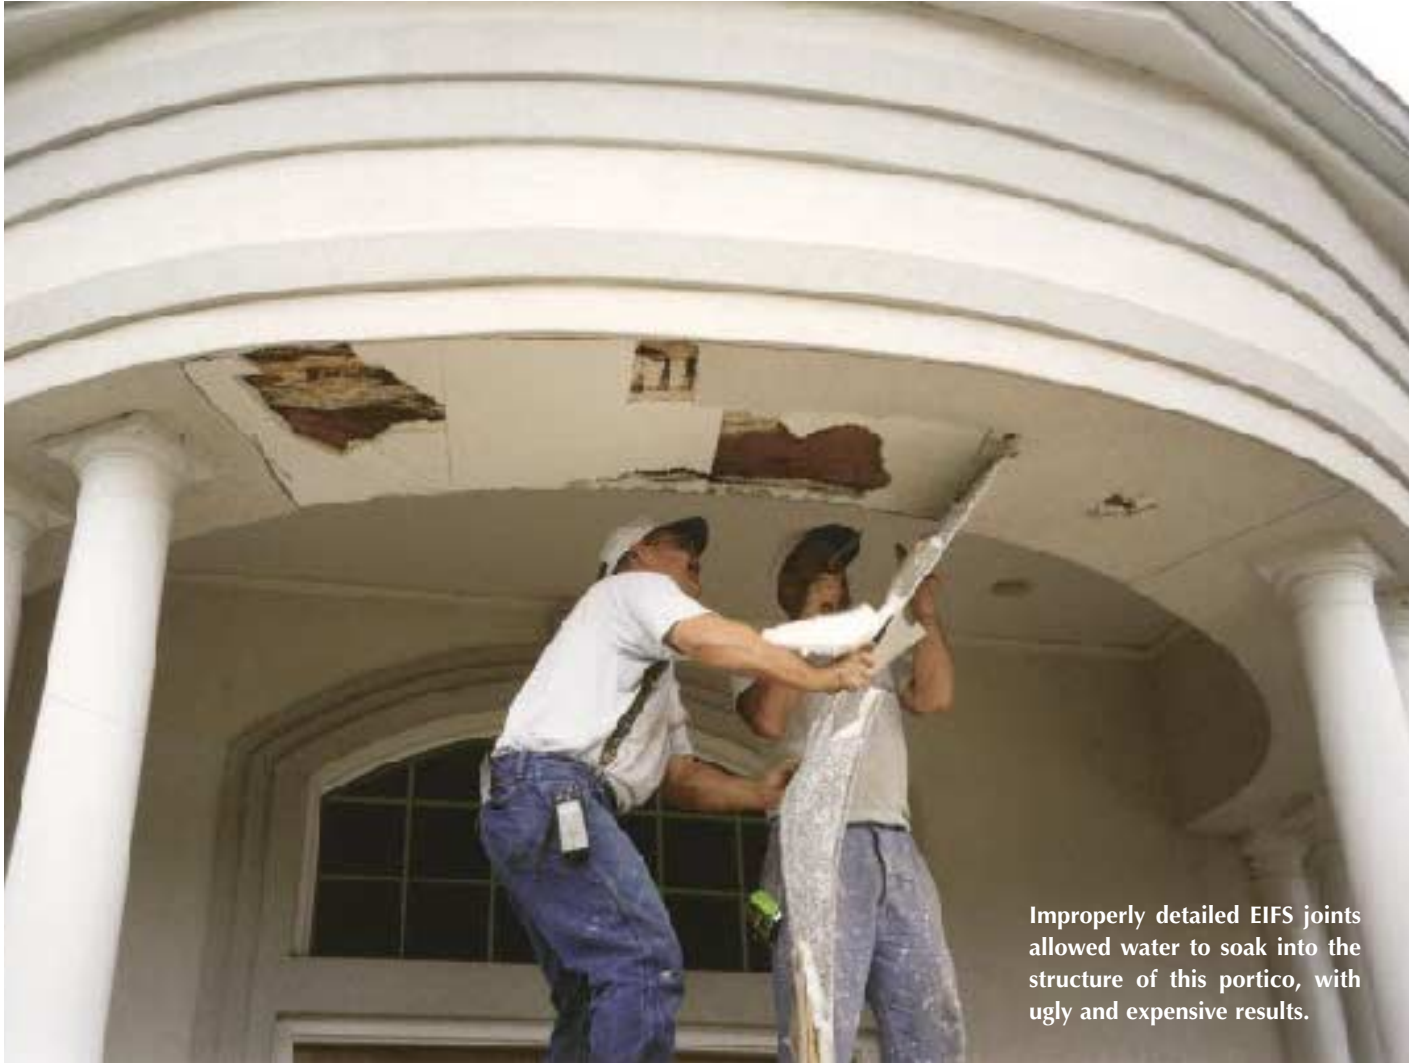
Improperly detailed EIFS joints allowed water to soak into the structure of this portico, with ugly and expensive results.

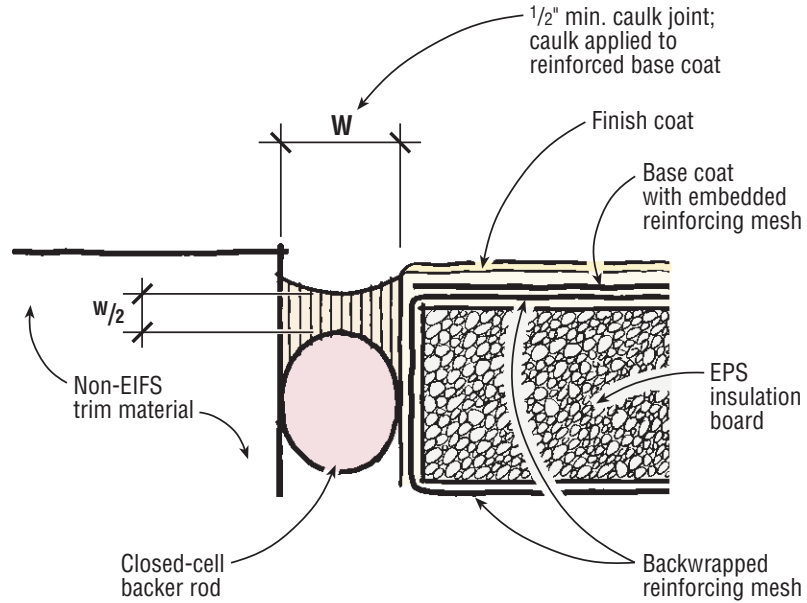
Properly Sealed Butt Joint

Figure 1. Wherever EIFS meets another material, backer rod must first be installed in the joint. This keeps the caulk from adhering to the back of the joint and allows it to stretch with building movements. A correctly tooled caulk bead has an hourglass shape that is about twice as wide as it is thick.

Good caulk, bad caulk. If it's going to last, the caulking has to be done right. The surface has to be clean and dry, the caulk space must be correctly filled with backer rod, and the caulk joint itself must be properly tooled (see Figure 1). The backer rod serves two functions: First, it prevents the caulk bead from

adhering to the back of the joint, allowing the caulk to flex in response to thermal expansion and contraction and other building movements. If the backer rod is omitted, the caulk will adhere to the back of the joint as well as the sides, limiting its ability to stretch and guaranteeing premature failure. Second, it controls the thickness of the finished application of caulk, which should ideally be about half as thick as it is wide.

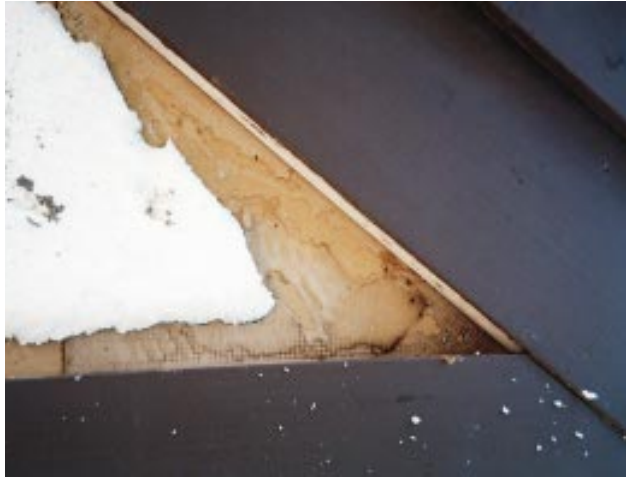
Figure 2. Moisture-soaked EIFS was butted directly against the gable-end trim in this photo. Water seeped through the resulting crack and penetrated the gypsum sheathing, which had turned to gray mud in some areas. Note the impression of the reinforcing mesh on the sheathing.

It's in the truck. More often than not, though, the caulk and backer rod are never applied at all. (I'm always told, "They're in the truck.") That was the case in the repair job photographed here, where the polystyrene board was simply butted against the trim and other surfaces (Figure 2).

When you butt EIFS up against another material, the edge of the EPS board is now exposed to water absorption, since there is not enough space to apply the base coat. The caulking, if used at all, has less than $1/16$ inch of EIFS surface to adhere to in order to seal against water entry.

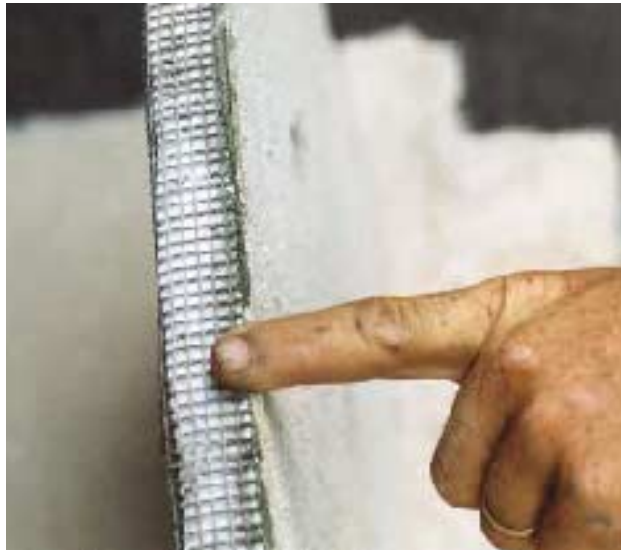
Figure 3. The EIFS applicator backwrapped the edges of the polystyrene with mesh, as specified — an empty exercise, because the tight spacing made it impossible to apply EIFS to the edges of the sheets.

I have even heard EIFS contractors try to defend themselves in a failed application by pointing out that they had diligently backwrapped the edges of the EPS board with mesh, as required. But unless the mesh-wrapped edges are also embedded in basecoat, this does no good at all (Figure 3).

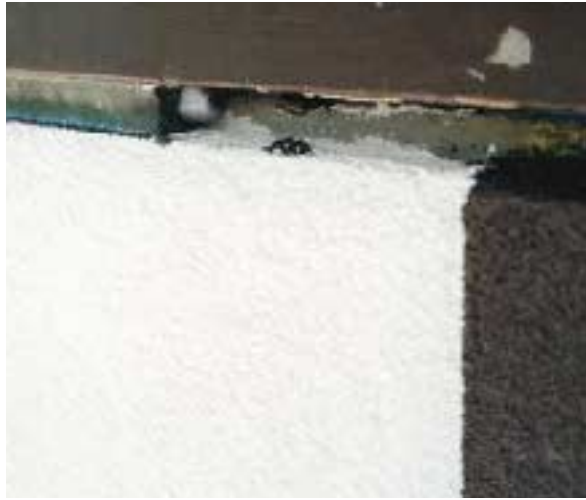
Figure 4. In a correctly executed butt joint — like the one in progress here — the edge of the insulation board is held back $1/2$ to $3/4$ inch, then backwrapped with mesh and base-coated. Note the backer rod and the well-tooled bead of caulk.

The solution in this case — as in so many others like it — was to tear off the improperly applied EIFS, repair the underlying water damage and rot, and reapply the EIFS system, this time leaving the required caulk spaces (Figure 4).

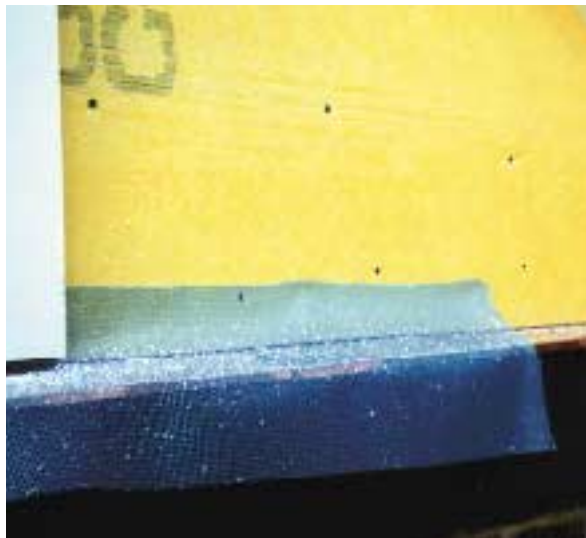
Figure 5. Headers and other horizontal surfaces must be protected with flashing. In this case, the damaged EIFS system has been stripped off, and a waterproof fiberglass-faced gypsum board screwed to the studs. The EPS board is attached to the sheathing with adhesive. Once the reinforcing mesh has been turned up at the front, the bottom edge of the sheet will receive a layer of basecoat.

last at least as long as the wall itself (Figure 5, page 3).

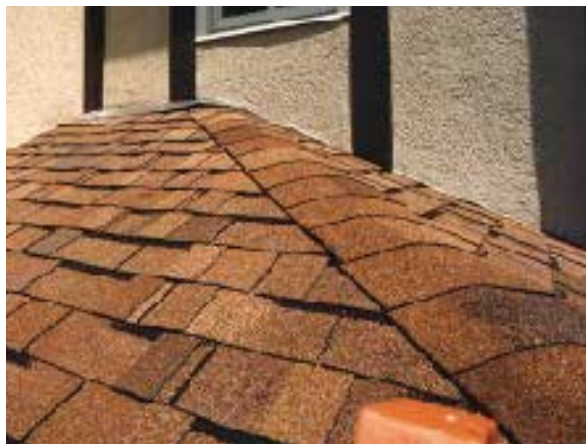
Figure 6. Contrary to the manufacturer's recommendation and common sense, the EIFS applicator butted the edge of the polystyrene directly against the roofing, with no caulk space or counterflashing.

Better step flashing. Another common trouble spot is the joint where a wall meets step flashing at the edge of the roof. More often than not, the EIFS-covered beadboard is simply butted and caulked against the shingles (Figure 6, page 3). Once this makeshift seal fails — as it soon does — the stage is again set for disaster as water wicks into the polystyrene, over the vertical leg of the flashing, and into the interior of the wall.

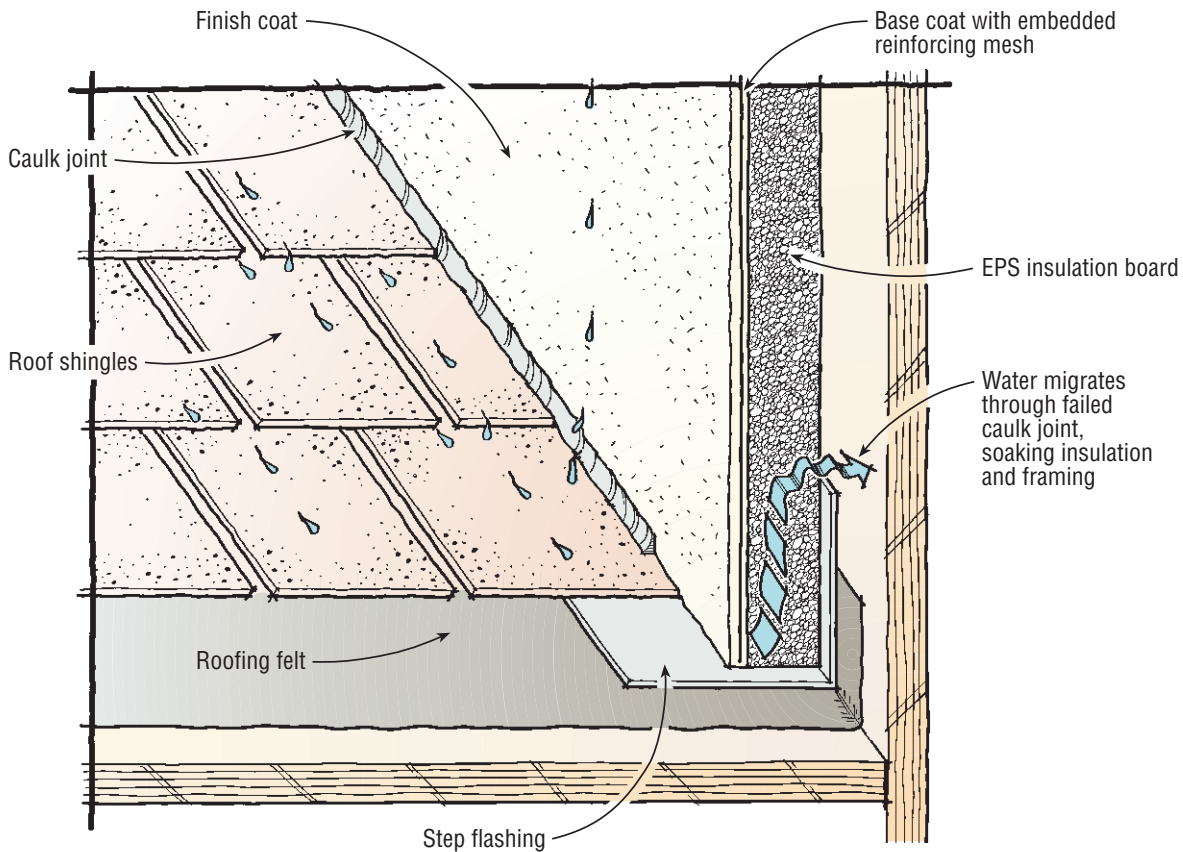
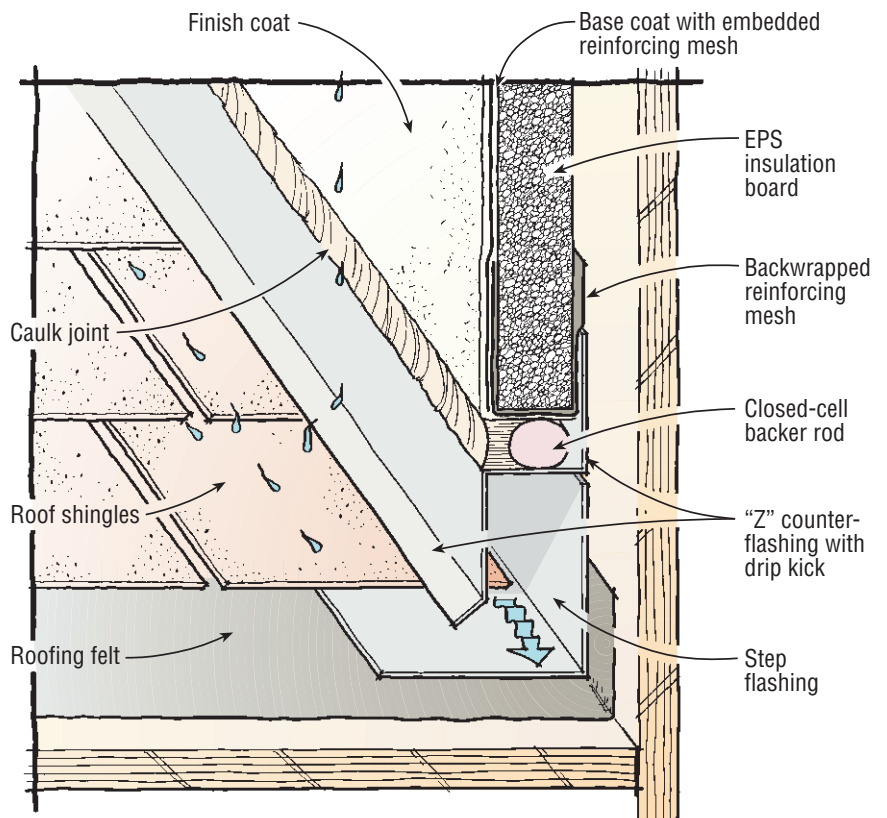
Incorrect Roof-To-Wall Installation

Figure 7. Where EIFS butts directly against the roof (above), water will wick up into the foam board and eventually make its way past the flashing into the framing. The correct approach is to use a shaped counterflashing above the step flashing (right). The additional vertical leg creates a ledge for caulk and backer rod, and it keeps the polystyrene board clear of water running along the roof.

Doing it right involves terminating the EIFS 2 inches above the roof, and including a run of counterflashing to provide a space for caulk and backer rod (Figure 7). When it's time to replace the original shingles, the roofer can slip the new shingles and step flashing beneath the counterflashing without damaging it.

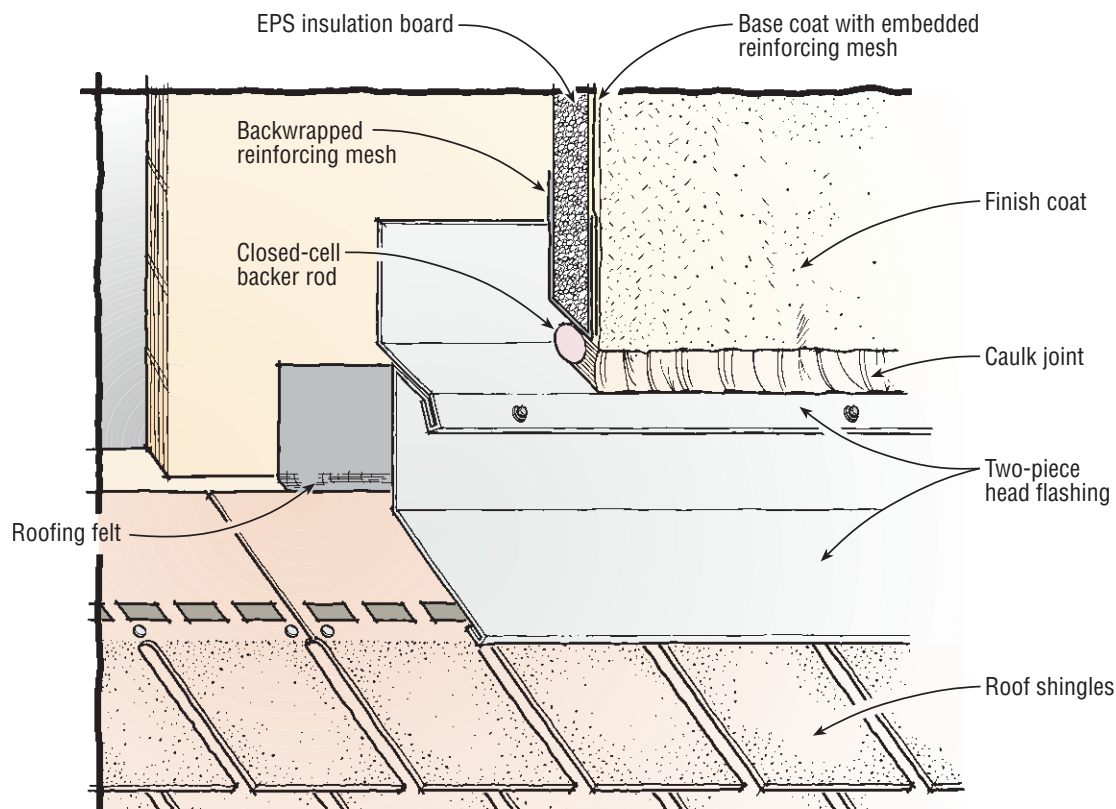
Head Flashing

Figure 8. This two-piece head flashing provides a caulk space and makes it possible to renew the roofing without mangling the flashing. The counterflashing is secured to the base flashing with self-tapping sheet metal screws.

Two-piece head flashing. In the case of head flashing — at the eaves wall of a dormer, for example — it's often impossible to replace the top course of shingles without bending the flashing

up out of the way. When it's bent back into place afterwards, the result can look pretty rough. Worse, bending and rebending the flashing can damage the caulk joint between the counterflashing and the EIFS, letting water seep through. A two-piece flashing like the one in Figure 8 allows the roofer to remove and reinstall the base flashing without affecting the counterflashing.
