Apex Home Inspections, LLC

Property Inspection Report:

May 7, 2011
9:30 am – 1:00 pm
Report # 6785

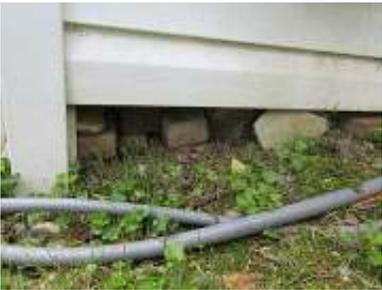
X		Crawlspace - floor	Dirt
				X	" Access	
X					" Ventilation	Louvers
			X		" Vapor barrier	
			X		Support piers	
			X		Support beam	
			X		Sill plate	
	X				1 st floor framing	- a gap was visible between the baseboard and the floor in the dining room. The floor framing may have dropped for some reason. Have a licensed building contractor evaluate conditions and make repairs as needed.

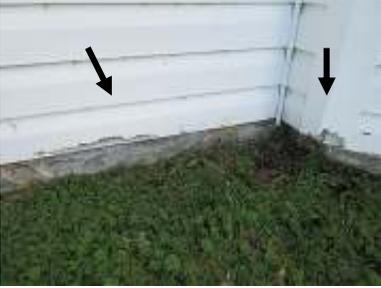
Serviceable	Recommend Repair	Maintain	Hidden, not inspected	Not applicable	Roof inspection: walked on back area, viewed 2 nd story roof from turret windows and with binoculars from ground	
					Items Inspected	Item Description/Comments
		X			Siding	<p>vinyl siding and brick - the bottom course of the vinyl siding was damaged in areas around the house.</p>

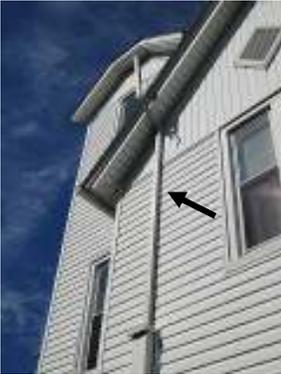
<p>- ask the seller the purpose of the gutter and chase on the right wall are for</p>

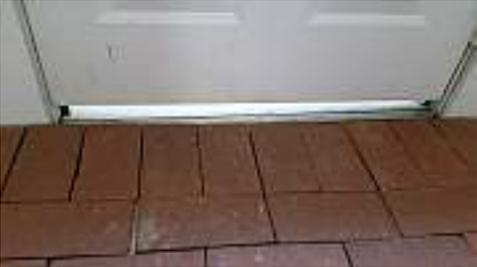
<p>- the front door lock and latch were not functioning. A slide bolt was used to secure the door.</p> <p>- a large gap was visible between the bottom of the side door and the threshold.</p>

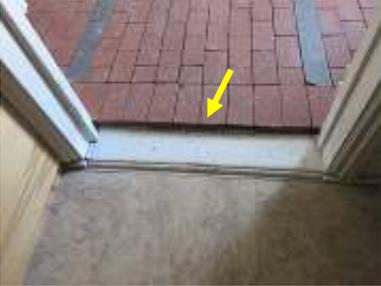
<p>- the brick floor in the entry behind the side door was higher than the threshold which can present a trip hazard</p>

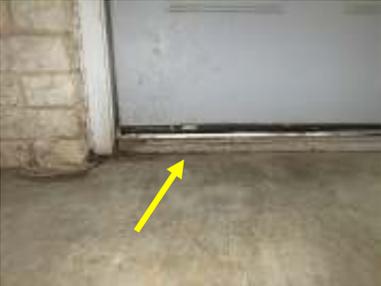
<p>- a gap was visible under the back door.</p>

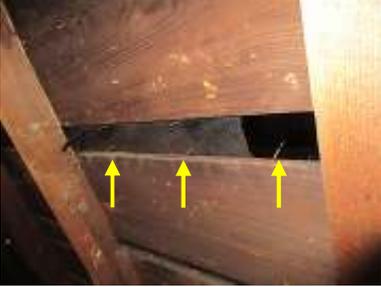
X			Roof covering	<p>Asphalt/fiberglass composite shingle</p> <ul style="list-style-type: none"> - the shingles on the original structure were laid over skip sheathing. The ends of roofing nails were visible in the attic. They did not have a roof deck to receive them. The gaps between the boards may telegraph as the roof ages and sags. Manufacturers call for shingle roofing material to be installed on a solid deck or on boards with a maximum distance of 1/4" between them, refer to the installation directions from the manufacturer. The life expectancy of the roof may be shorter than if it had been laid over a solid deck

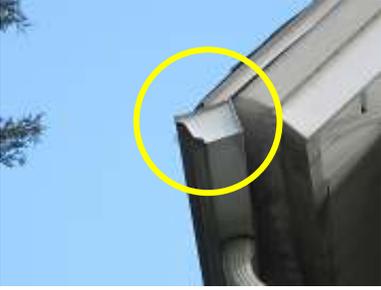
externally mounted, metal - the left front gutter on the 2 nd floor was not level.

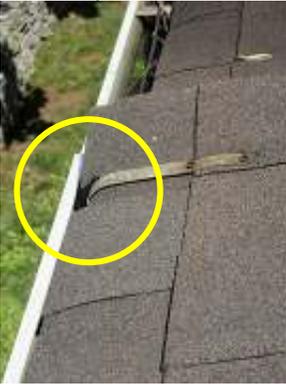
X			Gutters/Downspouts	- the gutters at the back of the house were filled with debris which can impede drainage - the gutter straps on the gutter over the side door tore the shingles. The edge of the roof overhang was reached the far edge of the gutter. Monitor condition to see if water overshoots the gutter. If so have a qualified gutter contractor make adjustments

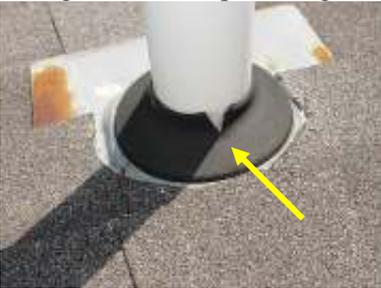
X				Chimneys	brick Note: the chimney for the fireplaces in the front rooms was abandoned and was taken down below the roof
X				“ Chimney caps	concrete
		X		“ Weather cap	- installing a weather cap atop the chimney helps prevent water, birds and vermin from entering the flue and keeps rain water from effecting any metal components.
					Plumbing vent stacks, chimneys - the gasket on the plumbing vent stack flashing had split

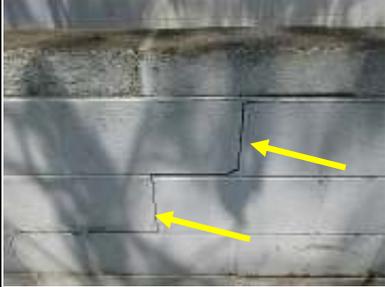
Serviceable	Recommend Repair	Maintain	Hidden, not inspected	Not applicable	Stoop: yes, back and right of house Porch: yes, not screened in, front of house Patio: yes, adjacent to outbuilding Deck: none Garage: none Carport: none Outbuildings: yes, back of property	
					Items Inspected	Item Description/Comments
	X				Stoop - floor	poured concrete - the left curb was loose
X					Porch - Floor	brick
X					Foundation	brick
X					Columns	wood
X					Railings/handrails	PVC
X					Steps	brick
X					Roof	Same as house
		X			Patio – floor	poured concrete - cracks were visible in the floor.
			X		Wall	concrete block - cracks were visible in the mortar joints between blocks. Seal the cracks; if they reopen have a qualified contractor evaluate conditions and make repairs as needed. The proximity of tree roots may have led to this condition

- the low height of the wall and the proximity of the retaining wall calls for a railing to be added to the wall to prevent adults and children from falling

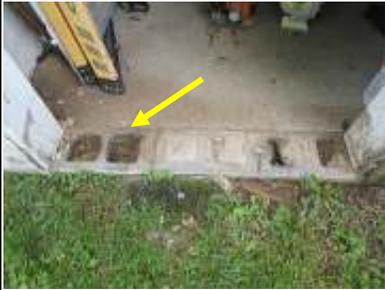
X				<p>poured concrete - some of the cells in the concrete block in the door opening were not filled in.</p>

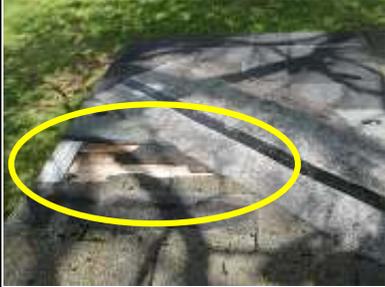
<p>- a section of shingle had come off exposing the roof deck</p>

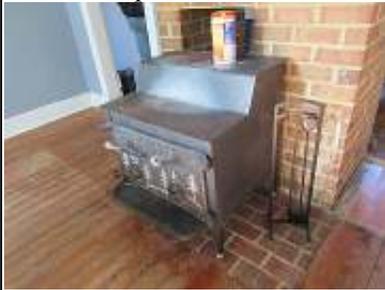
X				Electric baseboard	
	X			Auxiliary Heat	<p>- there was inadequate clearance to the combustible floor surfaces in front of the dining room wood stove's doors. Sparks and embers can fall on the wood floor when the doors are opened</p>

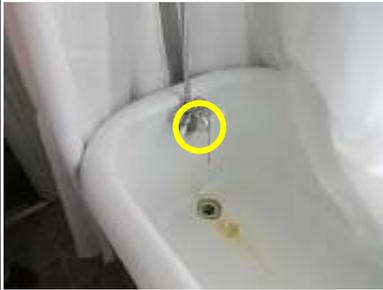
X					Waste cleanouts	
X					Water flow at fixtures	
X					Fixture drainage flow	
	X				Plumbing fixtures	- the handle from the kitchen sink hot faucet was missing - The upstairs bathroom's bathtub spigot opening is below the flood rim (top of tub) Under certain conditions the water supply pipes can become contaminated by backward siphoning. Today's building standards recommend a minimum clearance of 1" between the flood rim and the bottom of a spigot

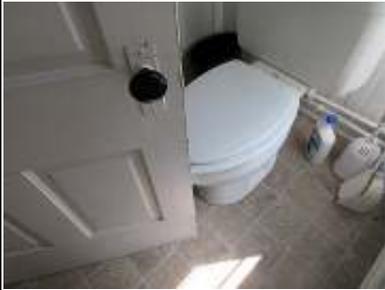
Serviceable	Recommend Repair	Maintain	Hidden, not inspected	Not applicable	Walls and ceilings: drywall, paneling, plaster, ceiling tiles Floors: wood, area rugs, vinyl, poured concrete Trim: wood, polystyrene Smoke alarms: no CO alarms: no	
					Items Inspected	Item Description/Comments
	X				Smoke alarms	Safety issue: Smoke alarms were not installed on each living level, in each bedroom and the hallways outside them.
	X				CO alarms	Safety issue: Carbon monoxide (CO) alarms were not installed. Gas and wood burning appliances were used in the house.
X					Floors	
	X				Walls	- the plaster was damaged in the ground floor closet off the living/dining room
X					Ceilings	
	X	X			Doors	- most of the doors would not close in their frames or remain closed due to the latch not catching. Maintain: the upstairs toilet room door's swing did not clear the toilet

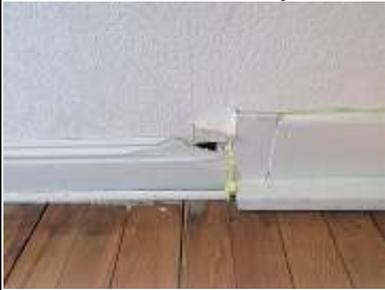
X				Trim	- the baseboard in the upstairs front bedroom was damaged. The interior of the wall cavity was visible

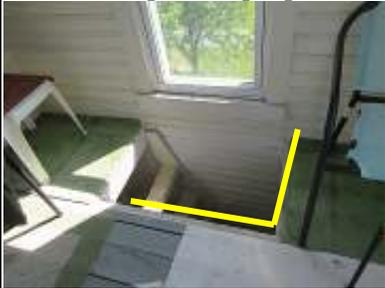
<ul style="list-style-type: none"> - the handrail on the back stairs did not extend the full length of the staircase - the ladder to the top floor of the turret was not secured to the wall or platform - a barrier was not installed around the openings on both floors of the turret to prevent people from falling

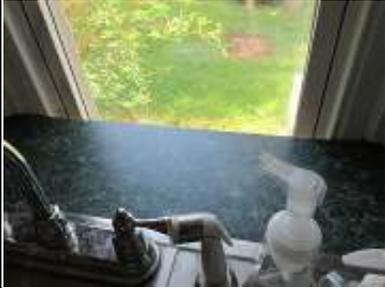
X					Bathroom	windows
X					Kitchen	Recirculating type
X					Kitchen – fixtures	
						<ul style="list-style-type: none"> - a back splash was not installed in front of the window by the sink to prevent objects from falling behind the base cabinet

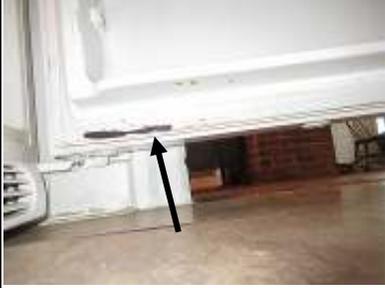
X			Dishwasher	- a screw was missing from one of the anchoring brackets under the counter top
	X	X			Refrigerator	- the bottom of the gasket was damaged on the refrigerator door
